# The impacts of human-induced disturbances on spatial and temporal stream water quality variations in mountainous terrain: A case study of Borcka Dam Watershed

Mehmet Özalp<sup>a,\*</sup>, Saim Yildirim<sup>b</sup>, Esin Erdoğan Yüksel<sup>c</sup>

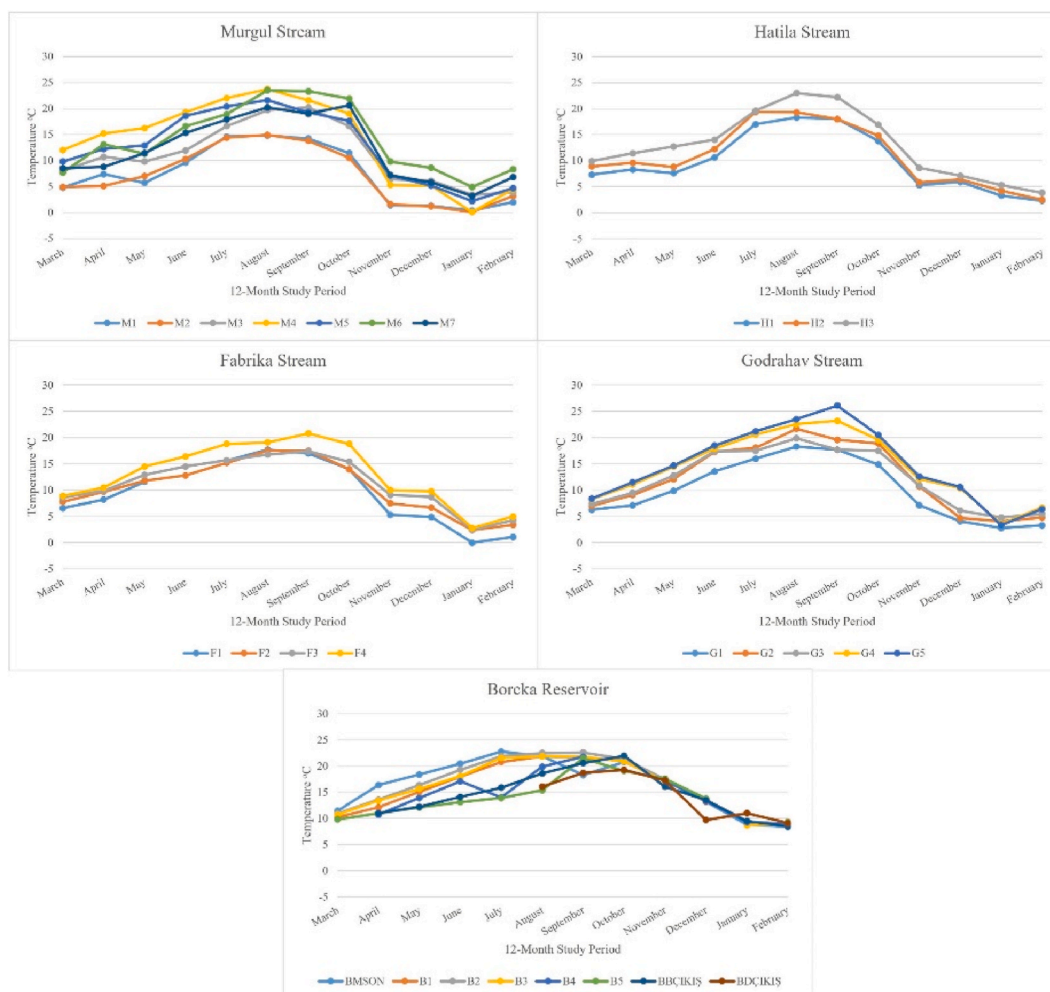
Fig. 8. Annual water temperature changes for the streams of Murgul, Hatila, Fabrika, and Godrahav and for the reservoir of Borcka Reservoir.

average stream water temperatures were close to each other with no significant differences among the four streams, significantly higher water temperature values -as expected-were detected for water in the reservoir (15.5 °C), (2). Here, the fact that the reservoir area absorbed more heat because of its large surface area and a stagnant water regime might be the main reason for this outcome. In addition, as is seen in Fig. 8, it was clear that the water temperature at the first sampling points (in higher elevations) was lower than at the sampling points close to the river mouth of each catchment, as stated by Hamid et al. [15].

This was expected because while the elevations of the first measurement points were 1495 m, 800 m, 1100 m, and 880 m for MSC, HSC, FSC, and GSC, respectively, the average elevation of the last measurement points (close to the reservoir) in the streams was ranging between 167 m and 195 m (Fig. 8). Similarly, In the bordering watershed (the Eastern Black Sea), measurements made only at the output points (close to sea level) of 11 streams yielded higher water temperatures ranging from 13.95 °C in Firtina Stream to 16.83 °C in Pazarsuyu Stream [36]. When evaluated in the scope of Surface Water Quality Regulation of Turkey, the temperature values of the stream waters in our project area were classified as “High-Quality Waters (1st Class)” since their values are generally below 25 °C [31].

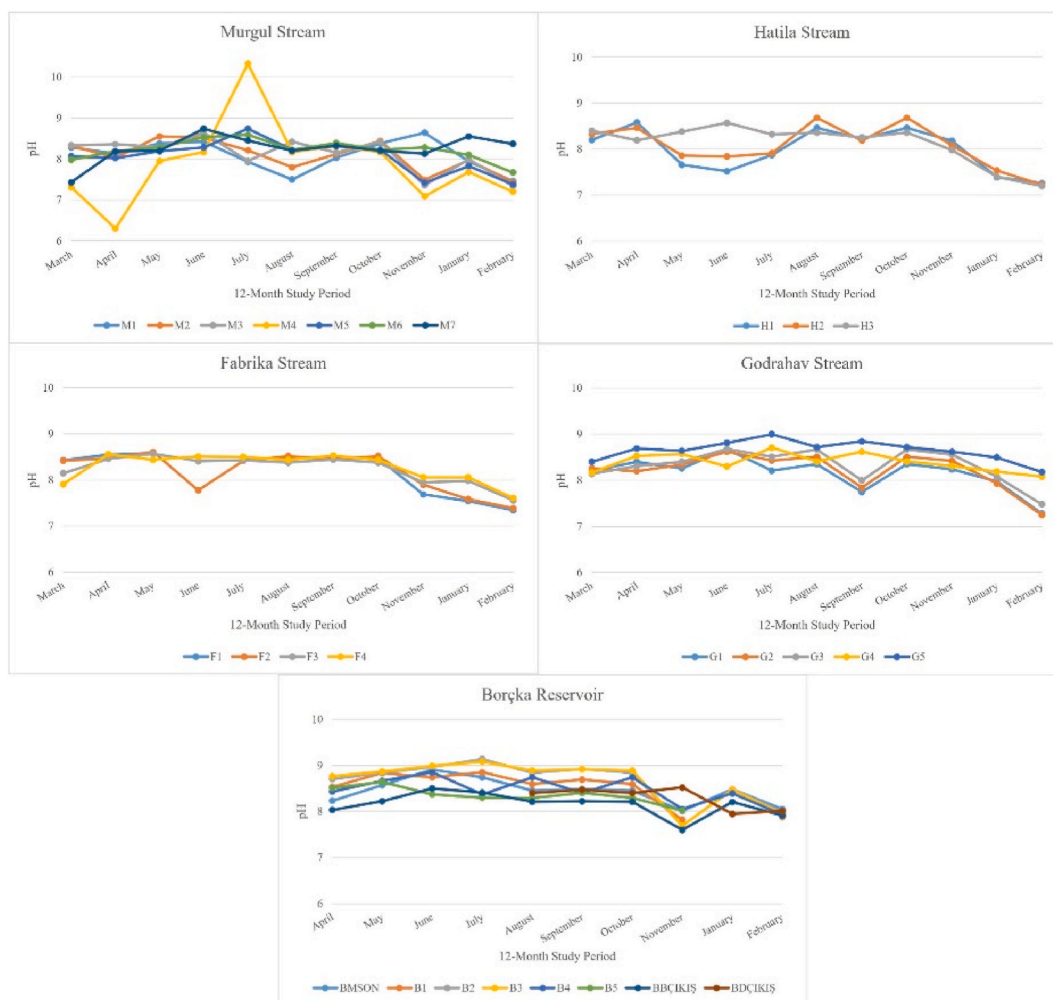
Fig. 9. Monthly changes of pH values for the streams of Murgul, Hatila, Fabrika, and Godrahav and the reservoir of Borcka Dam.

The monthly changes in pH values of both the stream and the reservoir waters in the study area are given in Fig. 9, while the ANOVA results are shown in Table 2. According to the Surface Water Quality Regulation and the World Health Organization, in general, pH values ranging between 6.5 and 8.5 are ideal for both natural and drinking waters [31,37]. As for the current study, when all the mean pH values of waters in all the streams and the reservoir were evaluated, it was noticed that the waters had a mild-alkaline characteristic with pH ranging from 8.11 to 8.44 (Table 2). In other words, Fig. 9 shows that there was no significant change in pH values because they all show a parallel trend from the source to the river mouth. However, statistical tests revealed that the reservoir waters had a substantially higher mean pH value (8.44) than the other four stream waters (Table 2). The M4 of Murgul Stream has the lowest (6.3) and highest (10.3) pH readings of all the sampling stations.

The main reason for both of these extreme pH values at M4 can be directly associated with the copper mine that has been operated within the higher parts of the Murgul Catchment since the 1950s, releasing wastewater to surface and groundwater resources from the mining activities (Fig. 2). In another study conducted in Murgul Catchment, similar findings were reported with the lowest (2.7) and the highest (10.8) pH values along the stream branches near the mining area [38]. Overall, when the data in Table 2 is evaluated, it is seen that the quality of stream water in all catchments of this study was generally in good condition (within the 1st class) with respect to pH, except for some measurements for M4 sampling point related with the mining area. In a study that was conducted to determine the water quality in the Kargı Stream of Antalya, pH values were measured between 7.03 and 9.4, and average values were reported to be between 7.87 and 8.26 [39]. For example, in this study, the annual average pH values were found to be between 7.5 and 8.5 as the pH values of the productive waters reported in the literature.

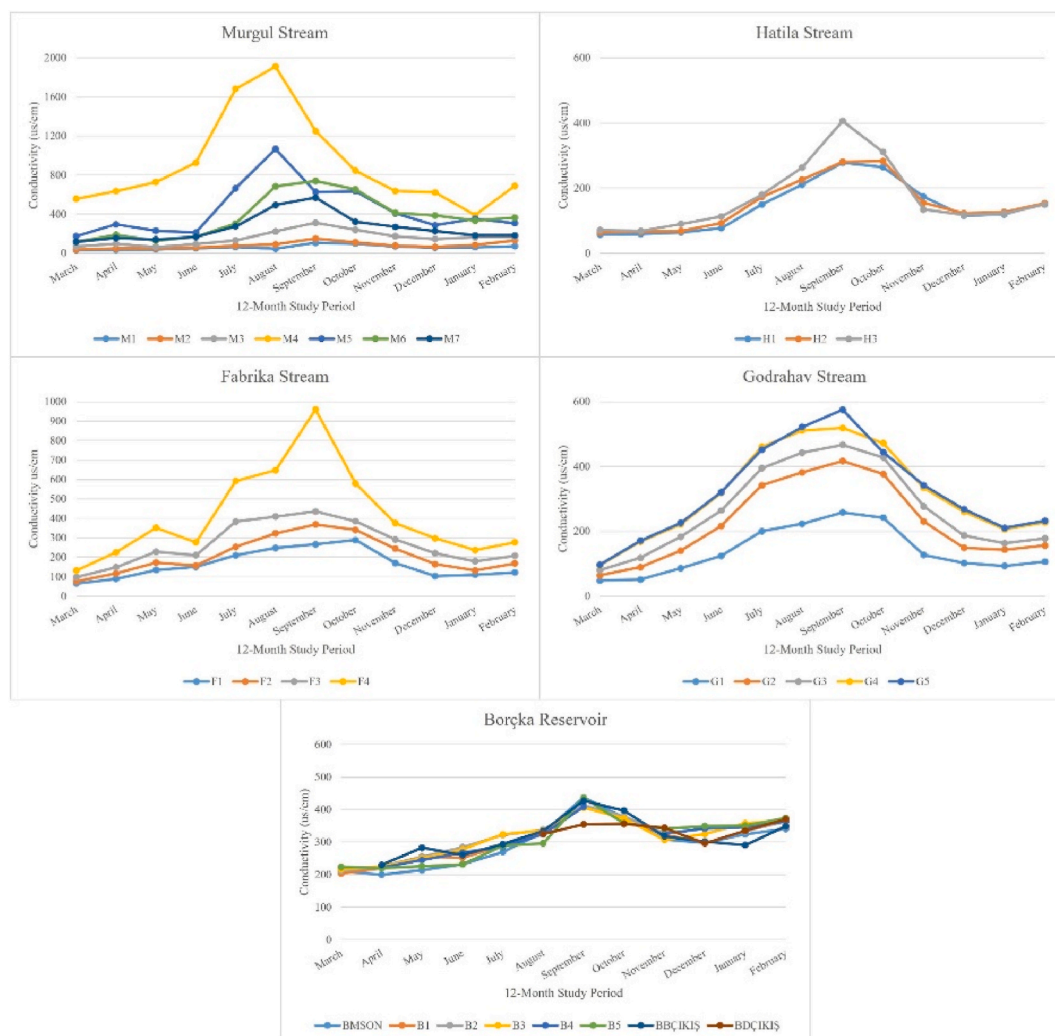
**Fig. 10.** Monthly changes of EC values for the streams of Murgul, Hatila, Fabrika, and Godrahav and the reservoir of Borcka Dam.

such as soil erosion from agricultural activities, wastewater from urban areas, both solid and dissolved ions from mining areas, and cut/fill materials from road constructions that have been ongoing since the construction of significant dam projects began in the mid-1990s. When comparing catchments with respect to EC, we can conclude that it is also directly related to various land use (e.g., forest, agriculture, settlement, etc.) types of each catchment in the study area as the amount and variety of dissolved substances reaching streams with surface flow changes according to land use [42]. For example, it was obvious to see the higher EC values at the last sampling point (F4) within the FSC, most probably because majority of the urban area of Artvin city center is situated in this catchment (Fig. 4), causing a large amount of materials to reach Fabrika Stream through wastewater and runoff. Also, it is presumed that the seasonal fluctuation in the graph of GDH occurred because of the high agricultural activities in this catchment. Here, it can be argued that there is a possible increase in the amount of dissolved substance reaching water resources because of excessive and improper fertilization in agricultural activities increasing electrical conductivity [41]. In the list of Surface Water Quality Regulations, it is recommended that the amount of electrical conductivity should be lower than 400  $\mu\text{s/cm}$  in waters of “1st CLASS” quality. Based on this viewpoint, in our study area, it is possible to argue that the conductivity values of all other points -except for the M4 point measured in the mining area of the Murgul Stream Catchment - M5 and M6 points were affected by the Murgul district settlement, and the seasonal increases detected at F4 point at the exit of the Fabrika Stream Catchment, are in “1st CLASS” water quality. However, there are also studies in the literature in which the electrical conductivity exceeded these limit values. For example, in a study that was conducted to determine the water quality in Kargı Stream (Antalya), it was reported that the average electrical conductivity values varied between 346 and 599  $\mu\text{s/cm}$  [39]. Also, in the study that was conducted in Tersakan Stream Watershed, where agricultural and residential usage was intense, it was reported that there was agricultural fertilization and spraying, and domestic and industrial wastes were intense. In this respect, it was reported that the lowest electrical conductivity value was 525  $\mu\text{s/cm}$  in spring, and the highest value was 610  $\mu\text{s/cm}$  [43]. In this study, at M4 and M5 points, which were the measurement points where the wastes caused by mining

activities and urbanization were mixed in MDH, the annual average electrical conductivity values were measured to be 877 and 477  $\mu\text{S}/\text{cm}$ , respectively. Also, an annual average of 412  $\mu\text{S}/\text{cm}$  was measured at F4 point in FDH, where domestic wastes, especially because of intense urbanization, were mixed.

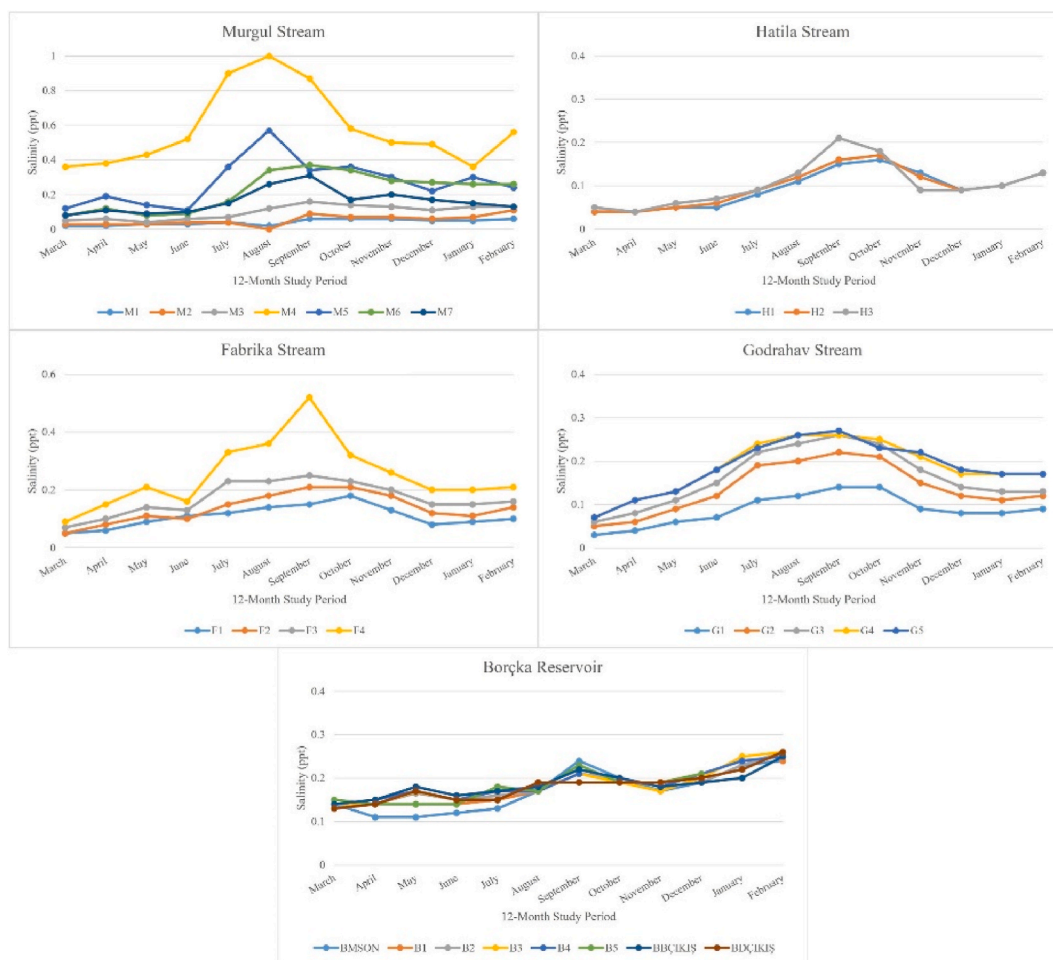
Fig. 11. Monthly changes of salinity values for the streams of Murgul, Hatila, Fabrika, and Godrahav and the reservoir of Borcka Dam.

In our study, as expected, the highest (1 ppt) and average highest (0.21 ppt) salinity values were detected in sampling locations along the Murgul Stream with the highest average value of 0.58 ppt found at the M4 point (Fig. 11). The main factor in obtaining this result was that this catchment is much more severely exposed to human-induced interventions such as (a) mining operated as open pits, (b) several RoR-HEPP projects (7 in total), and (c) the intensity of road and infrastructure works because of urbanization, compared to other catchments. In a similar study, seasonal averages of the values that were measured in the scope of determining the water and sediment quality in the Seydisuyu (Eskişehir) Watershed were measured as 0.28 g/L in autumn, 0.24 ppt in winter, 0.27 ppt in spring, and 0.3 ppt in summer [44]. When the graphs that show the salinity values of the catchments (Fig. 11) are examined, it is seen that the changes according to the months were in the horizontal direction in general, and there were fluctuations in Hatila and Godrahav Catchments. In this respect, it can be argued that the fluctuations in HSC are caused by the drinking water pipeline works in this catchment running parallel to the stream bed at some points. In these works, it is estimated that there might be an increase in salinity values as a result of the washing of the rocks in the excavation wastes poured into the stream bed during the expansion of the

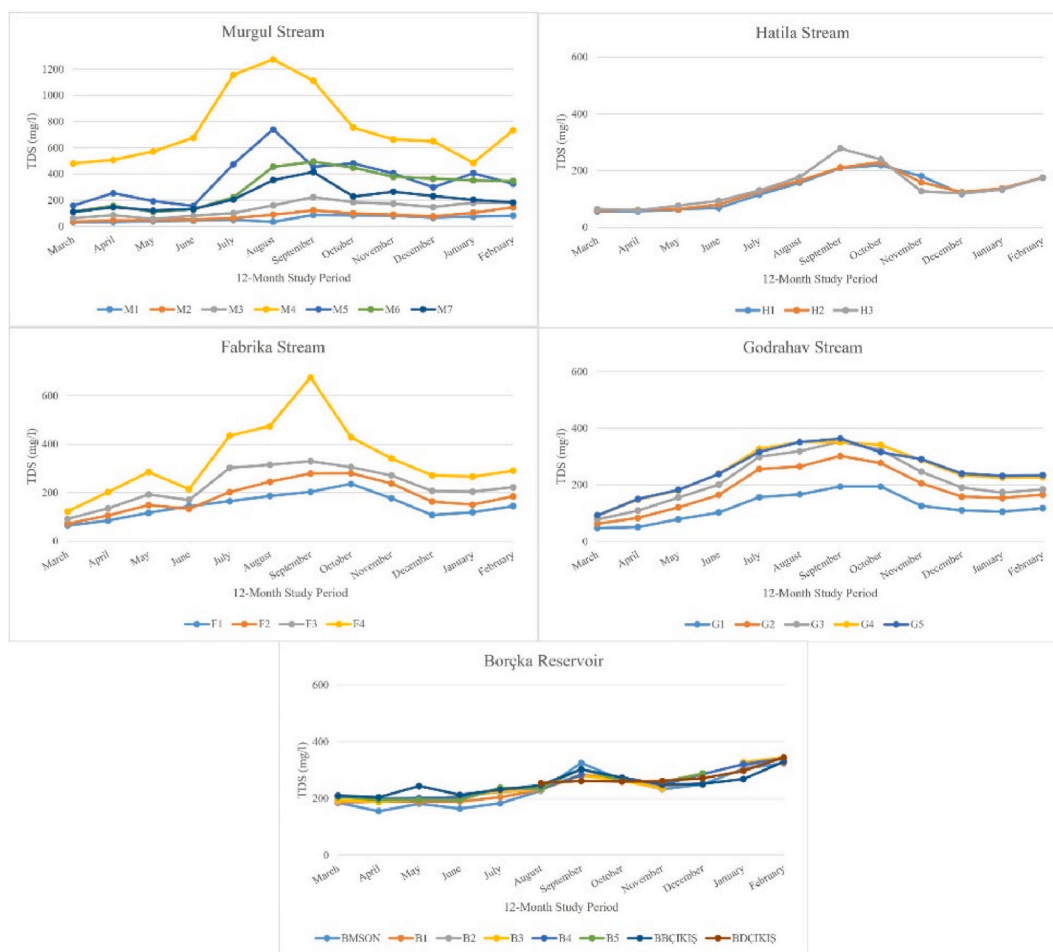
**Fig. 12.** Monthly changes of TDS values for the streams of Murgul, Hatila, Fabrika, and Godrahav and the reservoir of Borcka Dam.

It is presumed that while the excavation works regarding the new drinking water pipeline were the primary reason for the fluctuation of TDS in HSC, the fluctuation in GDH was mainly caused by agricultural and domestic activities, which is similar to the trend observed for EC. When the values in BBR were examined, it was determined that there were increased values in the months when the precipitation increased, which was an expected result because the water amount reaching the dam from streams, and therefore, the dissolved substance amount carried will also increase, especially in spring, with the increased melting snow and precipitation.

The water at the M4 point was determined to be “2nd CLASS” according to the Water Pollution Control Regulation -only with respect to the TDS- among all the measurement points in the study area [31]. It was reported in the literature that the average TDS concentration in water resources was 200 mg/L in mountainous areas [46]. In a study that was conducted on the rivers within the borders of the city of Trabzon, it was reported that TDS values ranged between 21 and 319 mg/L [47]. Literature shows that water resources containing TDS concentrations lower than 1000 mg/L are usually acceptable [34]. As stated in the previous studies, the TDS results showed a parallel trend with the outcomes of both salinity and EC values in this study as seen in Fig. 12, and Table 2. In addition, Pearson’s correlation indicated that there are significant relations between these three parameters.

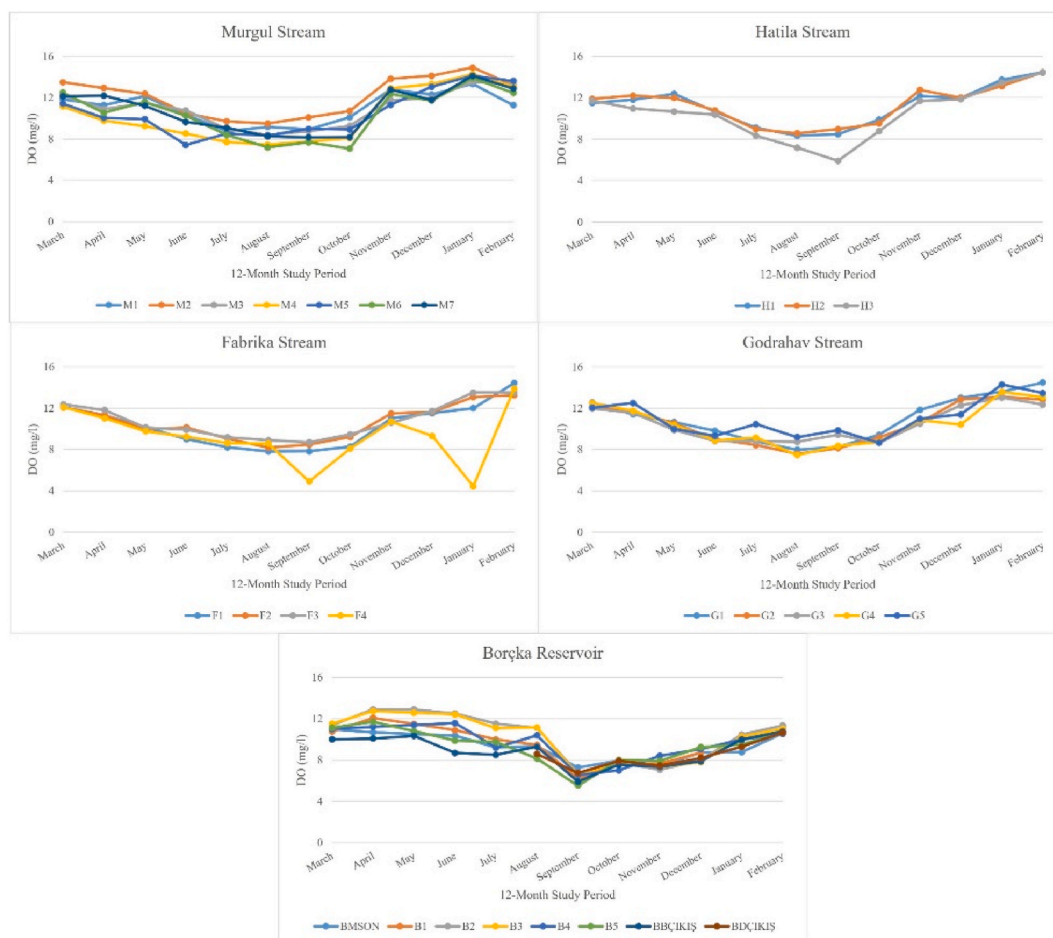
Fig. 13. Monthly changes of DO values for the streams of Murgul, Hatila, Fabrika, and Godrahav and the reservoir of Borcka Dam.

The major reason for the lower DO values in Fabrika Stream can be closely related to the anthropogenic wastes possibly causing DO levels to be impaired since the FSC consists of most of the settlement areas of Artvin city center and some agricultural lands; thus, the waters within this catchment receives significant amounts of both sewage (raw and treated, human and nonhuman) and agricultural runoff [1]. However, it can be concluded that according to the "Regulation on Surface Water Quality", the stream waters in the study area should be considered as "1st Class" (High-Quality Waters) with respect to the mean DO values since they were generally over >8 mg/L [31]. Also, it is known that the dissolved oxygen saturation varies inversely with salinity and temperature; similarly, it was seen that there was a tendency to decrease in dissolved oxygen amounts with increased temperature, particularly in the summer months of the study period (Fig. 13).

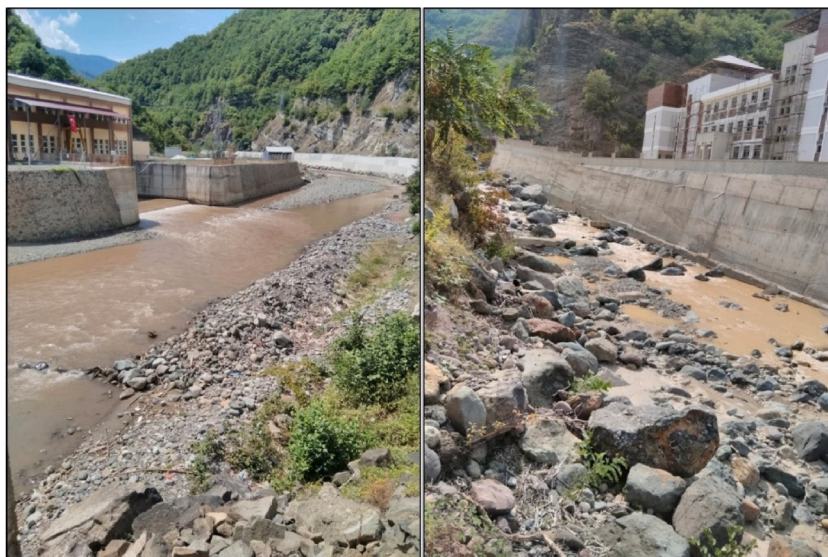
**Fig. 14.** The common application of constructing concrete walls along the streambed to stabilize the banks to protect both the roads and RoR-HEPP facilities (on the left), and houses/buildings (on the right) in the lower part of the Murgul Stream.

Similarly, when the sampling points in this study area were examined, it was also clear that the annual average TSS values generally tended to increase from the source to the river mouth for all the streams and catchments. However, various human-induced interventions can disrupt this balance by changing the natural structure of the channels, especially along the streams of Murgul, Fabrika, and Godrahav. For example, the construction of concrete walls along the streambed to stabilize the banks to protect both the roads, houses, and other structures as well as the establishment of several RoR-HEPP facilities for generating electricity are widespread within the catchment area of Murgul Stream [16,56] (Fig. 14).

Such structures and facilities operate as an impermeable barrier, allowing the natural movement of runoff water, sediments, organic materials, and other nutrients from the hillsides to the stream system, negatively impacting both the water quality and quantity of streams. Furthermore, it was projected that the TSS quantities would have several maxima in various months, many of which would be strongly associated to greater precipitation occurrences, notably in the spring months. (Fig. 15). For the current study, the mean TSS amounts varied significantly from 4.39 mg/L detected in the reservoir (due to the settlement of the materials with decreasing slope) to 71.25 mg/L detected in Murgul Stream (due to the intense disturbances) when all measurements were analyzed together (Table 2). However, among the sampling locations, the highest annual average TSS (with 236 mg/L) was calculated at the M4 sampling location within MSC. Since land use types of settlement, agriculture, and related activities in HSC (which covers most of the Hatila National Park) are quite limited, it followed a relatively more balanced course with respect to TSS values (Fig. 15).

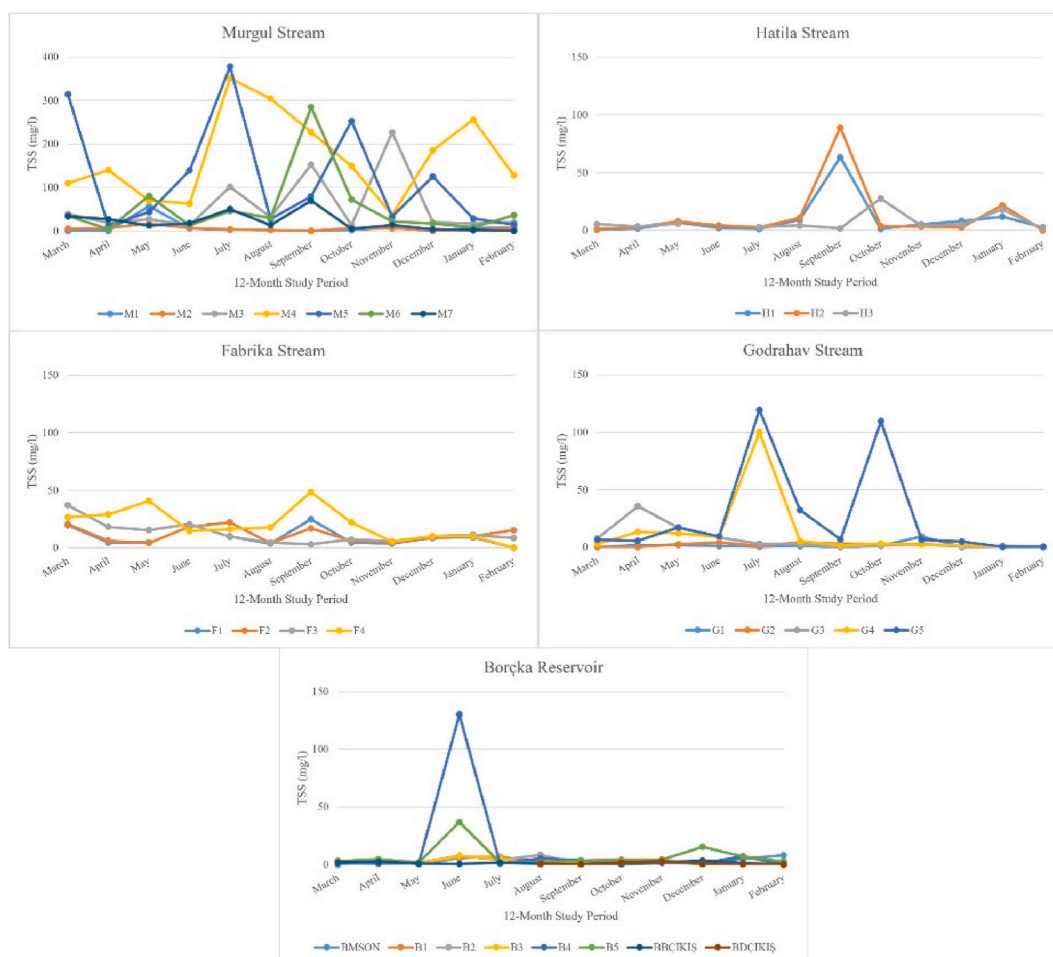
**Fig. 15.** Monthly changes of TSS for the streams of Murgul, Hatila, Fabrika, and Godrahav and the reservoir of Borçka Dam.

Higher TSS levels, on the other hand, were detected, particularly at the FSC and GSC exit points, due to high amounts of organic and inorganic materials (as well as soil erosion) reaching the streams from the relatively larger residential and agricultural areas found in these two catchments. Finally, when the monthly fluctuations in TSS amounts reaching the reservoirs are analyzed, it is discovered that

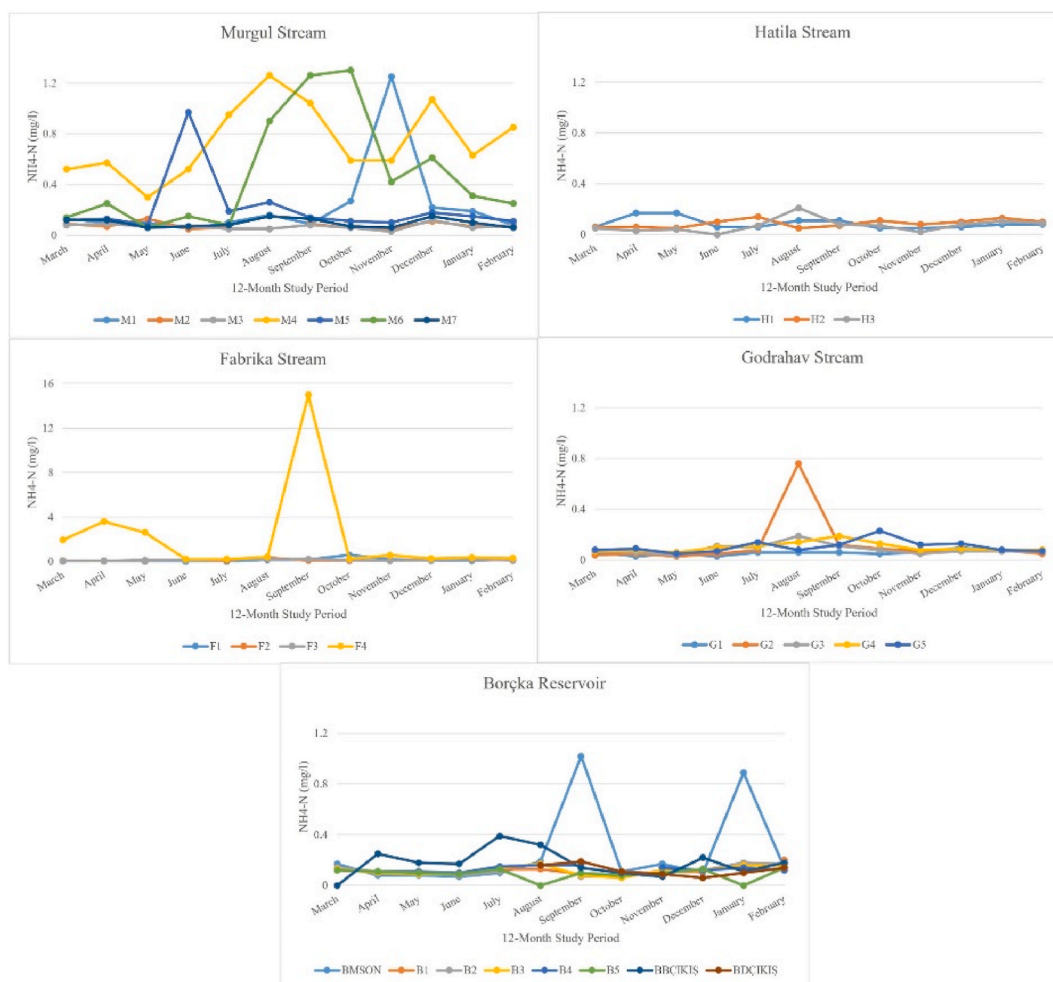
**Fig. 17.** Monthly changes of  $\text{NH}_4\text{-N}$  concentrations for the streams of Murgul, Hatila, Fabrika, and Godrahav and for the reservoir of Borcka Dam.

reservoir showed a rather fluctuating course almost throughout the year when compared to the Fabrika and Godrahav Streams (Fig. 17).

While the fluctuations of  $\text{NH}_4\text{-N}$  concentrations in the Murgul Stream can be associated with human disturbances along the stream (e.g. building new roads and infrastructure works), the activities of living organisms near the stream (e.g. increased decomposition, litterfall, etc.) might be the main reason for the Hatila Stream. It was reported in previous studies that up to 12 mg/L of ammonium could be detected in surface waters [68]; however, according to Surface Water Quality Regulation, the ammonium concentration must be less than 0.2 mg/L in 1st Class waters [31]. However, in the present study, it was seen that this limit value was exceeded at specific points and times in some catchments, which suggests that there might be pollution in water resources in terms of ammonium contents. When similar studies were reviewed, it was found that  $\text{NH}_4\text{-N}$  measurements ranged between 0.020 and 0.131 mg/L throughout the year in a study that was conducted in rivers in Eastern Black Sea Region [36,64]. It was reported in a study that investigated water quality in Tersekan Stream Basin within the borders of Muğla that  $\text{NH}_4\text{-N}$  measurements ranged between 0.5 and 0.72 [43].
