# Experimental investigation on story-to-column pounding between RC buildings via shake table tests

This study experimentally investigated the effects of story-to-column poundings between adjacent RC buildings through shake table tests. Two scenarios were considered: (i) without pounding and (ii) with story-to-column pounding. The tests were conducted on two 1/2 scaled 2-story RC frames, employing natural ground motion records. The accelerations, displacements, IDRs, and modal parameters of the test specimens were comparatively investigated. The experimental results revealed that pounding significantly influenced structural responses, causing severe shear damage in the columns of the test specimen due to story-to-column collisions. Pounding represented a critical loading condition, inducing abrupt spikes in acceleration responses and resulting in damage. Moreover, pounding caused decreases in displacement responses but led to abrupt increases in base shear forces. This resulted in irregular and asymmetrical hysteresis loops, indicating varying energy distribution in the pounding direction due to repeated impacts. The modal parameters also changed significantly due to the impact, a

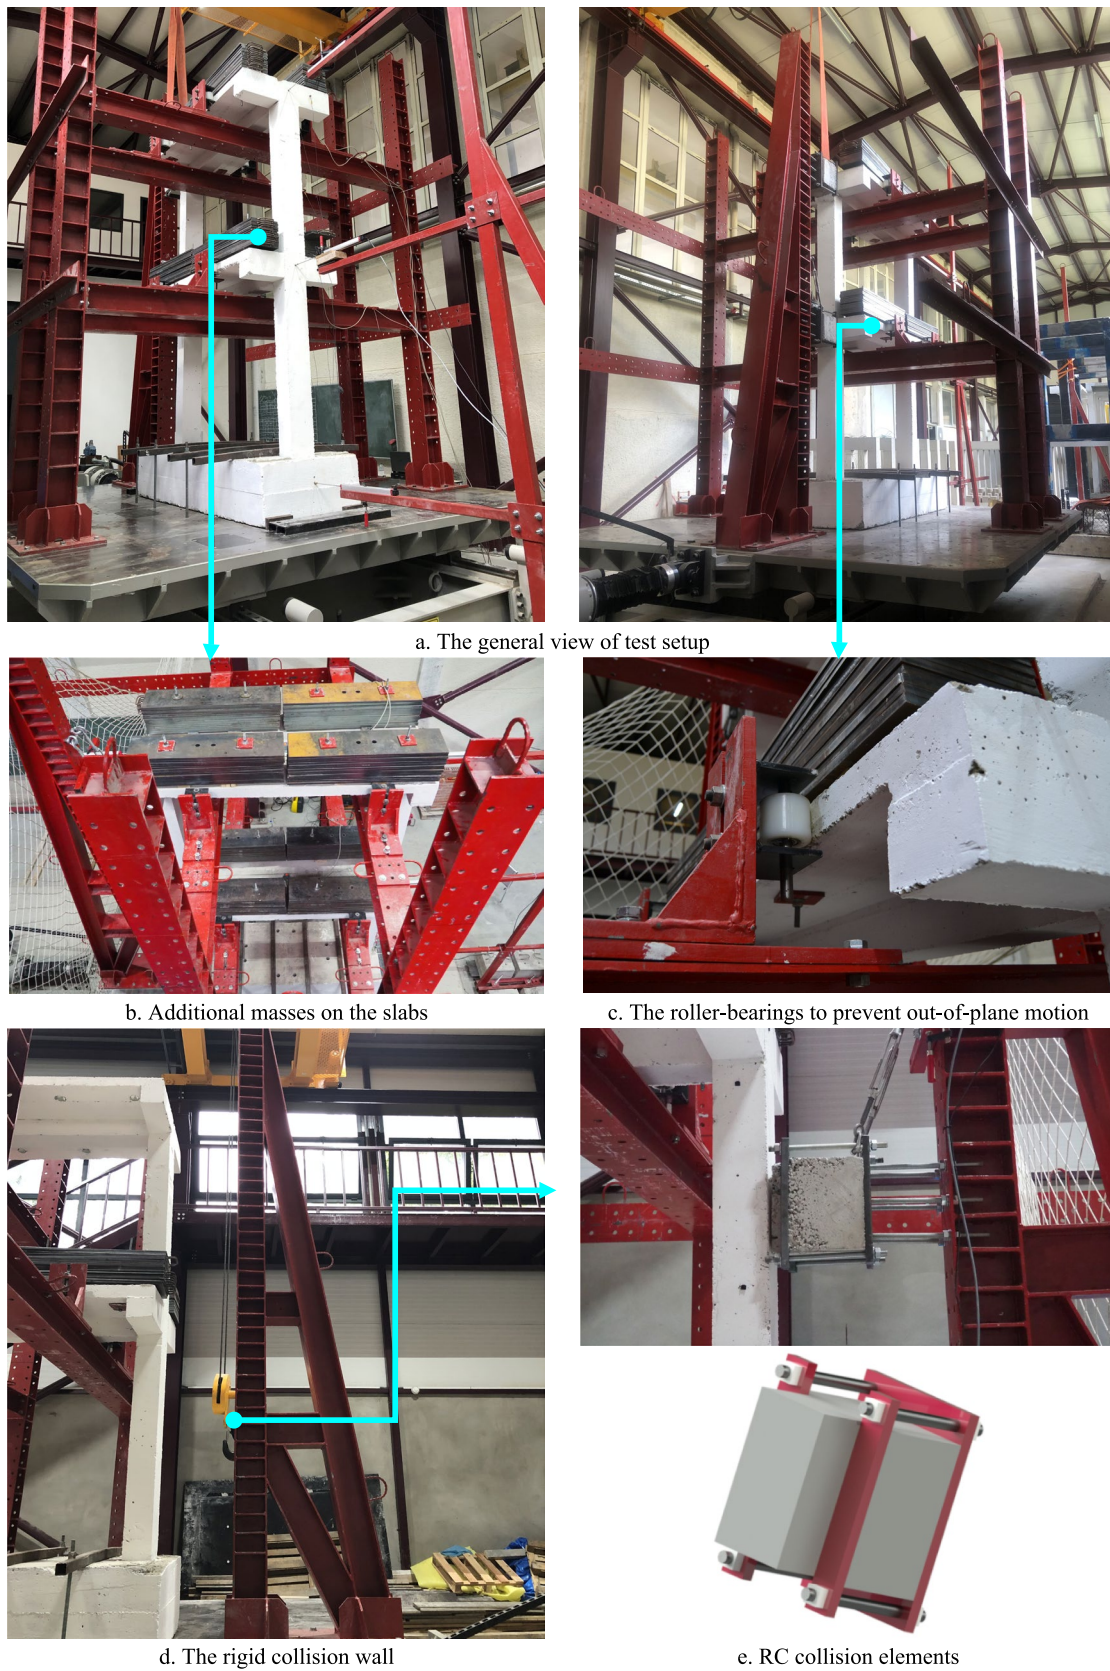
**Figure 4.** Experimental setup

The general view of the test specimens and experimental setup designed specifically for the pounding tests is given in Fig. 4. The alignment of the test specimens was meticulously adjusted to match the shaking direction. In order to counteract sliding or rocking motions of the RC frames, an appropriate connection was established between the foundations and the rigid platform. This was achieved using M20 steel rods at 16 different points in conjunction with steel box-section beams. Following the adopted simulation procedure, 1.70 tons of additional masses were allocated to each floor. To simulate these masses, steel plates measuring  $250 \times 1000 \times 16$  mm were employed on the slabs at each story level, fastened using 8 M14 rods (Fig. 4b). During the experiments, an array of 8 roller bearings was employed specifically to inhibit any out-of-plane movements of the RC frame (Fig. 4c). This system allowed the precise positioning of the bearings at designated locations on the specimens.

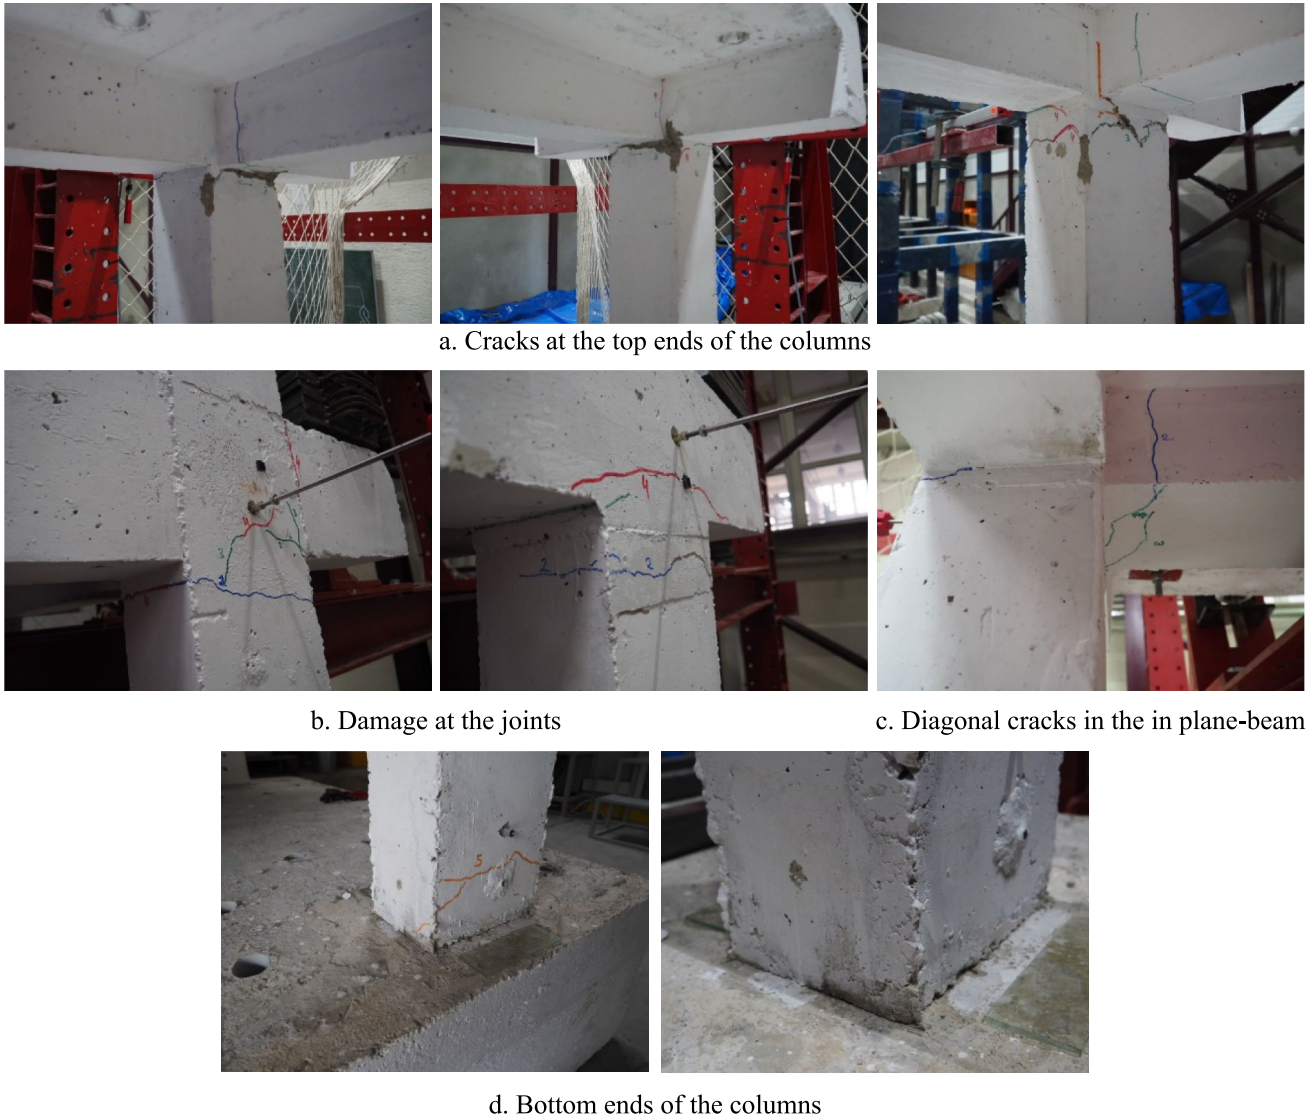
**Figure 7.** The damage distribution observed in the scenario without pounding effects

In the first test specimen, where collision effects were not considered, no visible cracks were observed after the ERZ25. The initial flexure cracks appeared following the ERZ50, which had a PGA of 0.25 g. These cracks were located at the upper ends of the columns on both floors, with widths smaller than 0.10 mm. Furthermore, diagonal cracks appeared in the in-plane beam on the second floor. After the third shake table test, conducted with the ERZ75 ground motion, the cracks at the upper ends of the columns and the joint regions propagated, though both existing and new cracks remained thinner than 0.10 mm. Following the ERZ100, cracks developed at the top ends of the columns, extending across all four faces of the section. In addition, new cracks were observed at the joints, and diagonal cracks appeared in all in-plane beams. Tests performed with the PARKF100 ( $\text{PGA} = 0.60 \text{ g}$ ) further intensified the damage. The width of existing cracks at the upper column ends increased significantly. Severe damage, including concrete spalling, was observed at the upper ends of the lower floor columns. Cracks also appeared at the lower ends of the columns, about 10.00 cm above the foundation surface. Separation at the interface between the foundation and columns was

particularly pronounced. The crack distribution obtained at the end of this test is presented in Fig. 7.

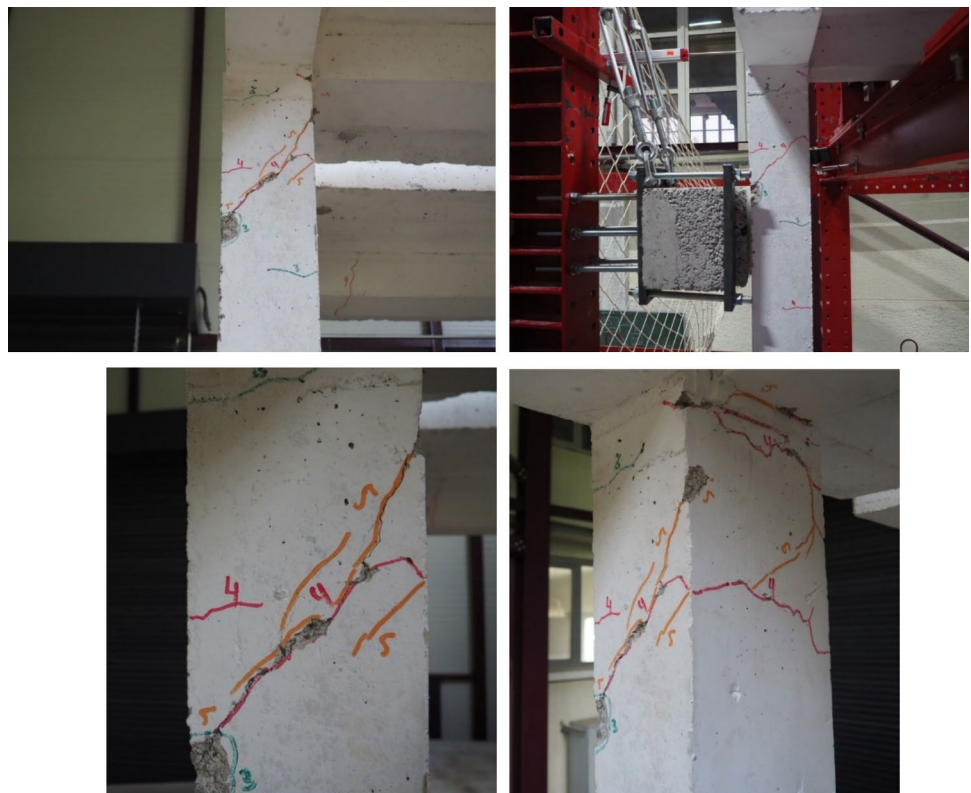
**Figure 8.** Shear damage observed in the second-floor column due to pounding

concrete was observed in the second-floor column. Following the ERZ100, shear cracks at an angle of approximately  $45^\circ$  developed in the second-floor column affected by the pounding. These cracks were marked on all surfaces of the column (parallel to the collision direction) and had widths less than 0.10 mm. In low-rise to mid-rise buildings, pounding typically occurs at the top floor. However, in high-rise structures where higher mode effects are significant, pounding may also occur at intermediate floors. Chau et al. [10] stated that if the high-mode response of either or both of the colliding buildings is excited, interaction can also occur at the middle levels of the buildings. In the present study, due to the two-story test specimens, the impact occurred at the second-floor level. Since the specimen approached the collision element at an angle during seismic excitation, the contact occurred between the upper portion of the RC collision element and the column. Therefore, shear damage in the column initiated just above this region (Fig. 8). Tests conducted with the PARKF100 resulted in a significant increase in the width of existing shear cracks in the impacted column. In addition, new shear damage due to pounding was observed, and the progression of cracks at the upper ends of the other columns was also recorded. Due to the interaction occurring between the slab and the column, this type of collision exhibits more destructive effects compared to other collision types. Columns subjected to such collisions are particularly exposed to extremely high shear forces. Past earthquakes
