# Structural response of half-scale pumice concrete masonry building: shake table/ambient vibration tests and FE analysis

**Abstract** Seismic performance evaluation of masonry structures is of paramount importance for ensuring the safety and resilience of buildings in earthquake-prone regions. There are limited number of studies on pumice elements in the literature. In addition, there are almost no studies investigating the earthquake behavior of pumice masonry building as a whole structure. In this context, a comprehensive understanding of their seismic response and dynamic characteristics has been lacking. To address this knowledge gap, a shake-table experimental campaign was undertaken, wherein half-scale pumice masonry building was exposed to simulated seismic forces. To enhance the experimental findings, numerical simulations were performed to confirm and expand our comprehension of how the pumice masonry structure responds to dynamic forces. Integrating both

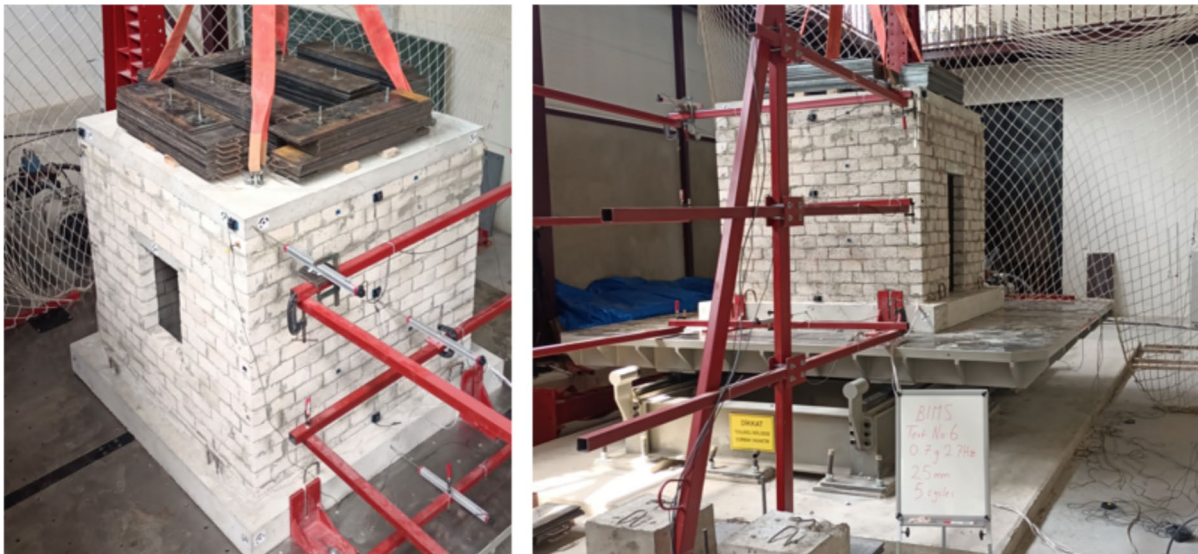
**Fig. 4** Additional floor masses on the slabs

laws, commonly preferred in most studies, were employed [55, 56]. Since the model dimensions were based on the dimensions and capacity of the shaking table, 2 scale factors were used. The geometric dimensions and scale factors of the scaled masonry model in this study were adapted from the measurements used in the research by Kaya et al. [33]. An artificial mass simulation approach was used to determine the masses to be added to the slab in the shake table tests [57]. The additional mass to be added to the structure is calculated by Eq. 1.  $M_{m1}$  is the story mass to be added to the specimen,  $M_p$  is the unscaled building weight,  $S_L$  is the scale factor, and  $M_{m0}$  is the mass of the specimen. As a result of the calculations, the additional masses to be placed in the slab were determined to be approximately 2300 kg. These weights were connected to the experimental specimen slab with steel plates with dimensions of 250 mm × 1000 mm × 16 mm with 14 M14 rods in 6 sections (see Fig. 4).

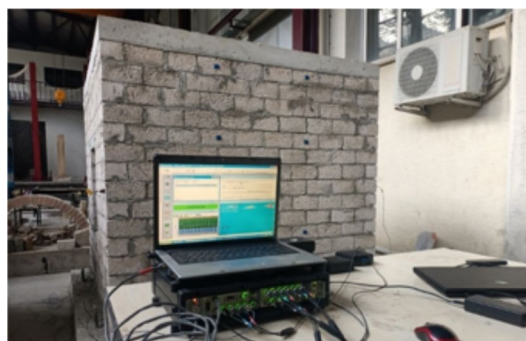
**Fig. 7** The setup and location of the accelerometers for the ambient vibration test

for the ambient vibration test is depicted in Fig. 7. Four triaxial accelerometers with a frequency range of 0.3–2000 Hz are placed at the top corners of the model where the vibrations are concentrated. The signals from the accelerometers are transferred to a 17-channel B&K 3560 data acquisition system. In parallel with studies in the literature, each OMA test was taken for 15 min. The signals were then processed with OMA [37] and PULSE [62] software. The mode shapes exhibited by the building type structures are longitudinal translation, transverse
