## Tracking surface and subsurface deformation associated with groundwater dynamics following the 2019 Mirpur earthquake

Muhammad Younis Khan, Ekrem Saralioglu, Syed Ali Turab & Sher Muhammad

The Mirpur Mw 5.8 earthquake on September 24, 2019, produced extensive liquefaction-induced surface deformation (LISD) in the surrounding villages. Due to the complexity of seismic hazards and the occurrence of their effects on a large spatial scale, the resulting surface, and subsurface deformation are often poorly resolved. To cover spatially extended LISD, the PSInSAR technique provided subsidence and uplift rate values ranging from  $-110$  to  $+145$  mm/yr consistent with the spatial distribution of the mapped liquefaction features. The most prominent surface change occurred in Abdupur and Sang villages. GPR measurements were conducted to map the near-surface cracks produced by transported liquified sand into the shallow subsurface layers and other liquefaction features (elevated groundwater table, conductive clay pockets, fractures, sand dikes, and water-enriched zones). Thus, the GPR survey assisted in the reconstruction of these structural and hydrogeological features on the near su

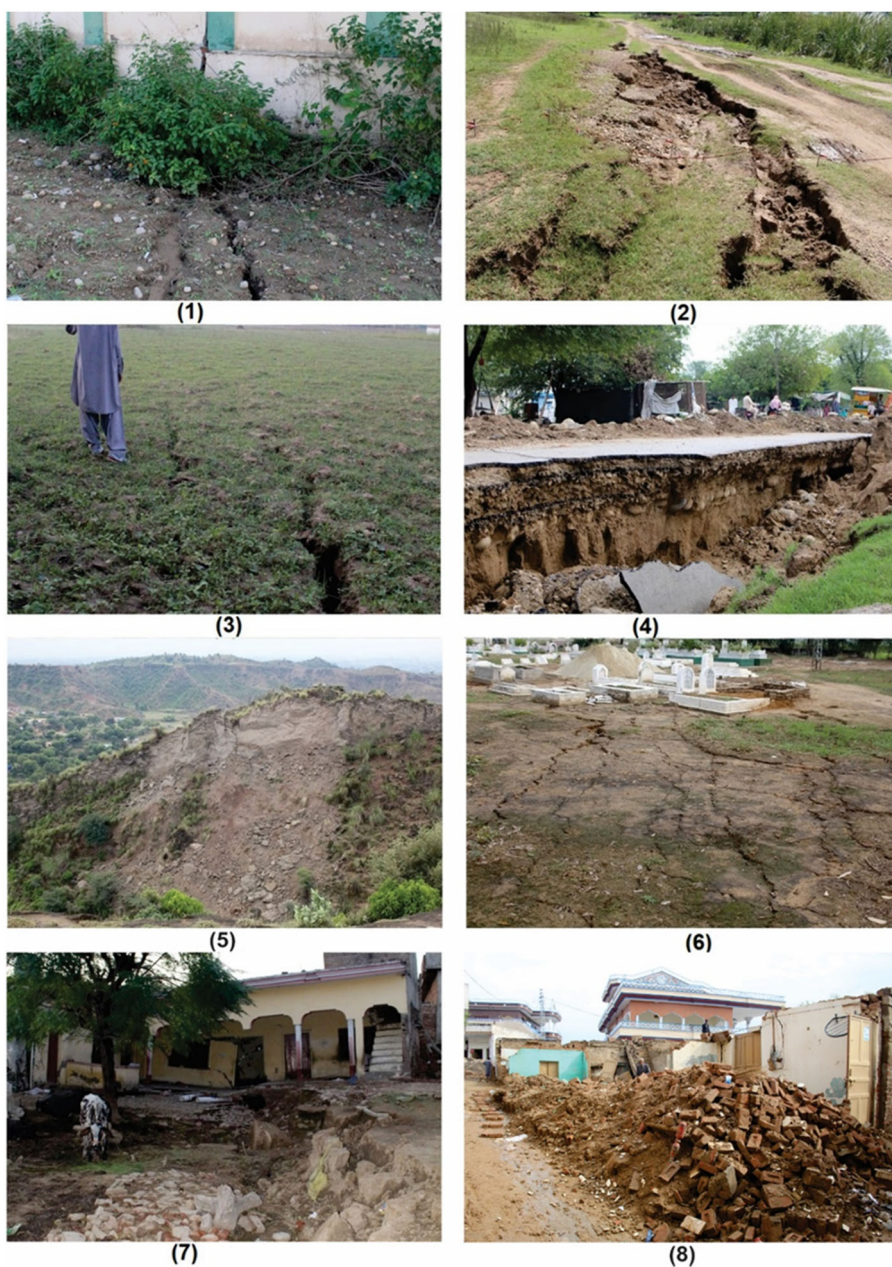
**Figure 2.** Field photographs showing ground deformation at various locations (1-8, see [Figure 8](#) for their locations). surface fractures in the field (1-3,6); damaged infrastructure (4,8); small-scale landslide (5); and ground subsidence/uplift (7).

Fractures running along the canal banks were 0.5–160 cm wide and 6–187 m long and were characterized by vertical and lateral displacement and subsidence of coherent sediment masses toward the canal (location 4 on Figures 2 and 8; Khan et al. 2021a). These fractures are oriented parallel to the UJC (i.e.  $\sim N60^{\circ}W \pm 15^{\circ}$ ). Predominantly, fractures found at a distance of  $>50$  m from the canal bank (i.e. at sites S1–S8) displayed width and length of 0.5–50 cm and 4–134 m, respectively. However, at site S2, the fracture width, and length reached 180 cm and 280 m, respectively. Most of the fractures displayed lateral extension, with some showing vertical movement of 2 cm to 135 cm (locations 2 & 7 in both Figures 2 and 8). Modest left lateral strike-slip movement (0–15 cm) was also recorded along a few fractures at sites S1, S5, and S7 (Figure 3f of Khan et al. (2021a)). All the fractures are striking towards  $N25^{\circ}W$ – $N45^{\circ}E$ .
