Yuzuncu Yil University  
Journal of the Institute of Natural & Applied Sciences

**The Impact of Weapon Systems on Structural Damage and Progressive Collapse: A Case Study of Belgorod Oblast**

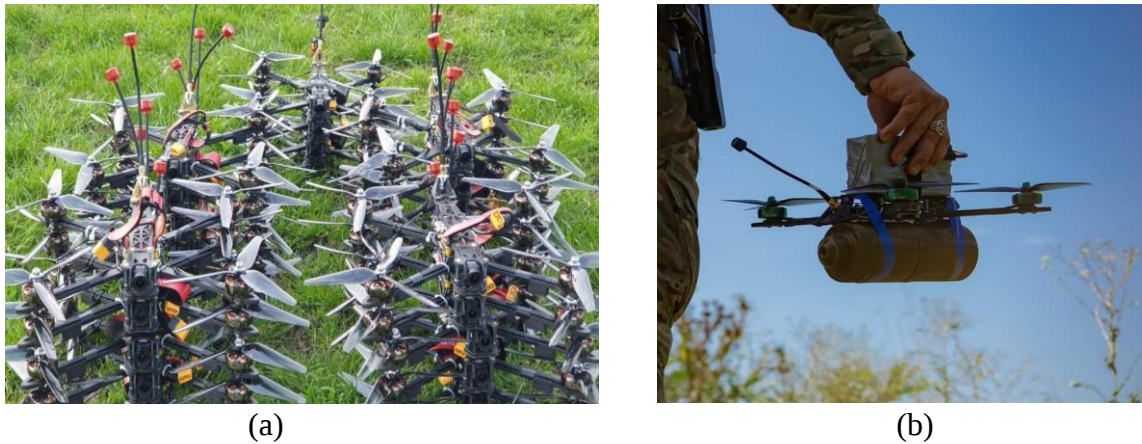
Figure 3. FPV Drones (Militarnyi, 2023) a) FPV Drone appearance b) FPV Drone with payload.

FPV (First-Person View) kamikaze drones are remotely controlled unmanned aerial vehicles equipped with explosives. These drones are primarily used for military and security purposes and are usually designed for one-way missions. They are typically equipped with explosive payloads and complete their missions by crashing into targets or detonating at specific locations. High-resolution cameras and low-latency video transmission systems are used to allow the operator to control the drone with precision. These drones are generally equipped with some explosives and aim to cause damage by

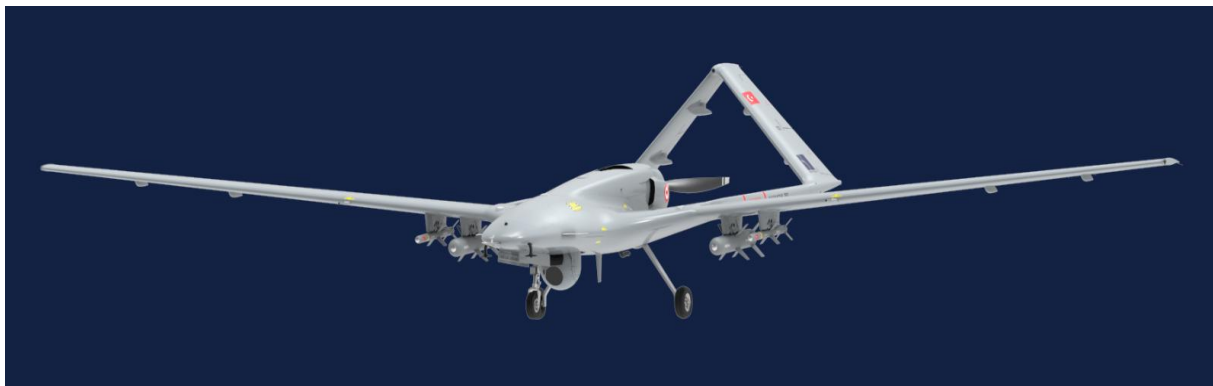
Figure 4. Bayraktar TB-2 (Baykartech, 2024).

From the table above, it can be assessed that the Leleka-100, Punisher, RQ-20 Puma, and Spectator-M1 UAVs, which are solely for ISR missions, are not capable of causing damage to structures. In contrast, the Bayraktar TB2 and PD-2 UAVs, which have attack roles, are capable of causing damage to structures. These UAVs, which carry munitions, sometimes target buildings and other elements. The Leleka-100, Punisher, and Spectator-M1 are manufactured by Ukraine, the RQ-20 Puma by the USA, and the Bayraktar TB-2 and PD-2 by Türkiye. The Bayraktar TB-2 is shown in Figure 4, and the PD-2 UAVs are shown in Figure 5.

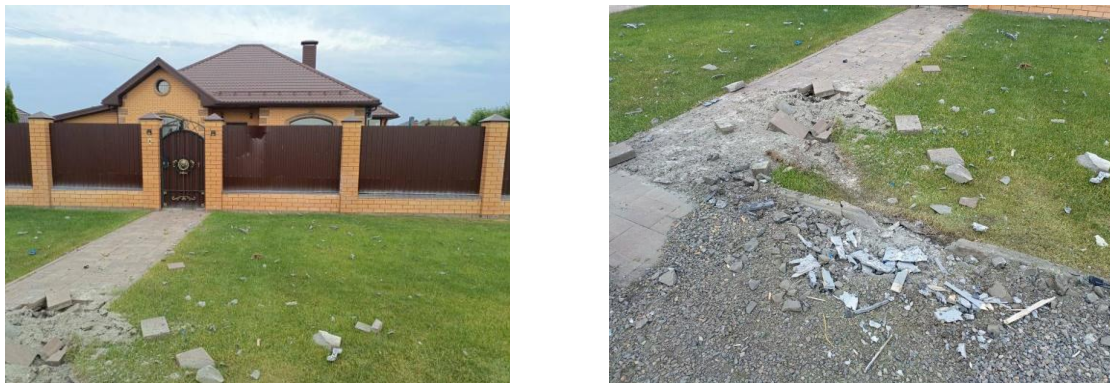
Figure 9. An example of attacks that did not cause structural damage (Governor of Belgorod, 2024).

In some cases, attacks occur near structures without causing any damage. Many such attacks have been recorded. Explosions around infrastructure facilities, auxiliary buildings (barns, outbuildings), wildfires, various equipment, motor vehicles, and military vehicles have been disregarded unless they caused damage to structures. Two images of such incidents are provided in Figure 9.

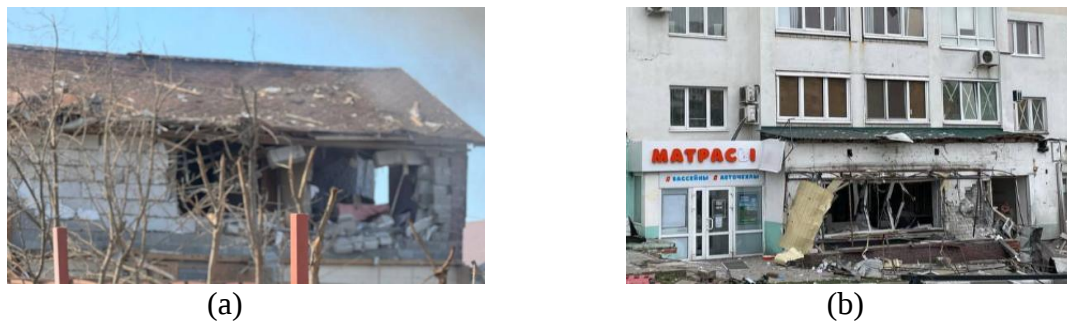
Figure 11. Examples of Moderate Damage are a) Collapse of non-load-bearing wall and roof damage and b) Damage to facade, windows, and doors along with porch and mechanical systems damage (Governor of Belgorod, 2024).

The figure shows two buildings from the Belgorod region in Russia, both moderately damaged due to the attacks. The image on the left (a) depicts a house that has sustained significant structural damage. Part of the roof has collapsed, and there are visible cracks in the walls caused by external forces or a catastrophic event. The image on the right (b) shows a commercial building with a damaged ground floor. The storefront is severely damaged, with debris scattered around. This damage likely resulted from an explosion or a similar impact.

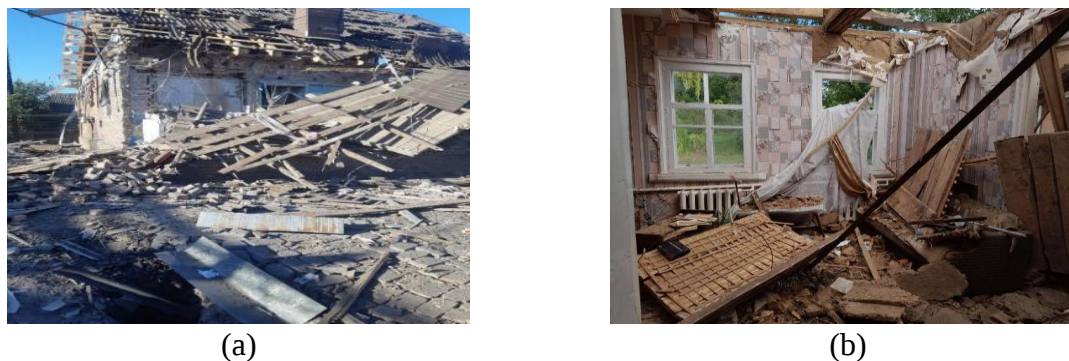
Figure 12. Examples of Severe Damage are a) Severe exterior damage to the structure and b) Severe interior damage to the structure (Governor of Belgorod, 2024).

Figure 12 shows examples of two different structures that have sustained severe damage. The heavily damaged buildings are presented as a result of the attacks in the Belgorod oblast. The image on the left (a) depicts a building that has suffered significant structural damage, with most of the roof completely collapsed and the walls of the building largely destroyed; such damage renders the structure unusable and requires extensive repairs. The image on the right (b) shows severe interior damage, with the ceiling and walls of the room largely collapsed and the interior completely ruined; windows and other structural elements are significantly damaged. Such damage typically renders the structure completely unusable and requires extensive repairs or rebuilding.

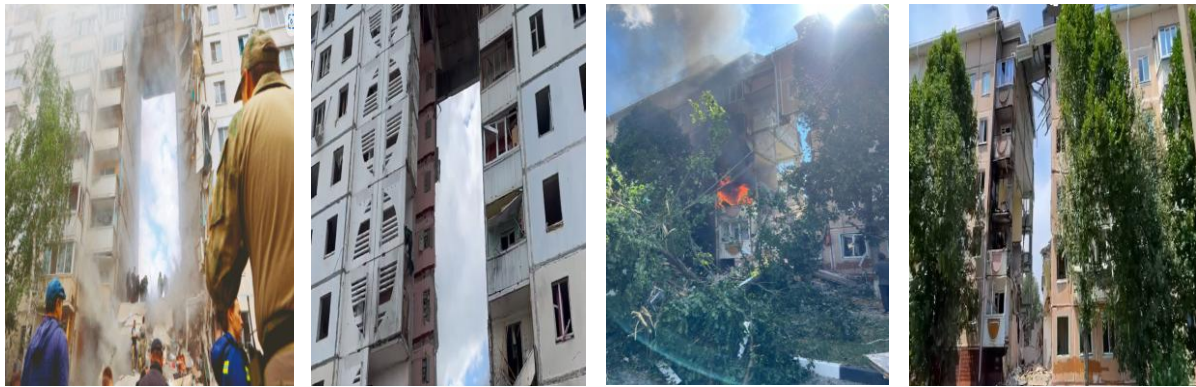
Figure 13. Examples of Progressive Collapse (Governor of Belgorod, 2024).

Figure 13 shows examples of progressive collapse in buildings located in the Belgorod region of Russia. The top two photos and the bottom two photos depict the same structure. Such collapses can occur due to structural failures and may be exacerbated by external factors or internal weaknesses. These incidents highlight the importance of engineering and regular maintenance. The visible damage and smoke indicate significant structural weaknesses and emergency response efforts. The initial damage during the dates examined was caused by bombardment and MLRS (Multiple Launch Rocket System). Damage to one or several load-bearing elements disrupts the balance of the structural system, resulting in the collapse of a portion. This type of collapse, compared to other structural failures, is characterized by casualties, injuries, and socio-cultural and political consequences.

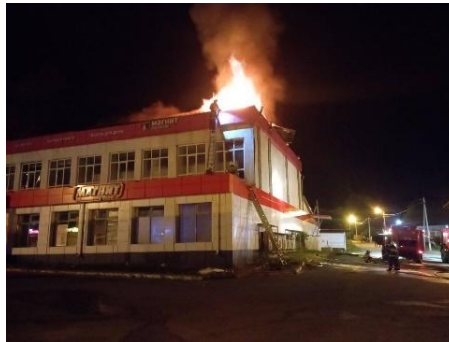
Figure 14. Damage to the structure caused by FVP (Governor of Belgorod, 2024).

Such attacks are frequently encountered in modern warfare; however, there are no recorded instances of FPV drones causing progressive collapse in structures. While they can cause significant damage, this can only happen indirectly. Drones cannot cause severe damage to structures built with non-combustible roof and facade materials. This type of attack can only be useful in specific and sensitive locations and does not have an impact strong enough to initiate a progressive collapse mechanism in buildings. Another type of modern attack is the use of UAVs. Although various UAVs are manufactured, Table 5 provides details on the types of UAVs used, their missions, and whether they can cause progressive collapse in the attacks conducted in the Belgorod region.

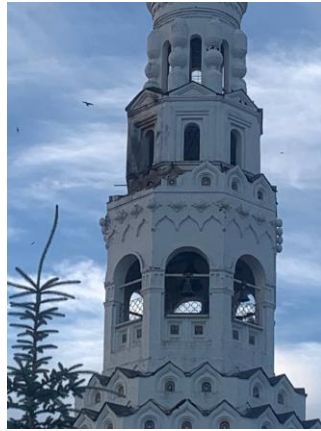
Figure 15. Example of damage caused by UAV to structures (Governor of Belgorod, 2024).

Figure 15 shows an example of damage caused by unmanned aerial vehicles (UAVs) to a structure. The impact of UAVs has resulted in noticeable damage to the structure. Such attacks can create structural weaknesses and collapse risks in the upper parts of the structure. Particularly, historical and architecturally valuable buildings become more vulnerable to such damage, increasing the need for repairs. The visual clearly demonstrates the potential destructive effects of military and strategic UAV uses on civilian structures. Additionally, the destructive impact of UAVs can vary depending on the type of attack and the amount of ammunition carried. UAVs generally have more destructive effects than compared to drones; however, in terms of progressive collapse, they currently have limited capability to initiate a chain collapse mechanism like drones. On the other hand, shrapnel fragments, which may not be a direct attack type but an indirect effect of an attack, have been observed to cause unexpected damage to structures. Figure 16 shows the damage caused to a structure by elements neutralized by air defense systems.

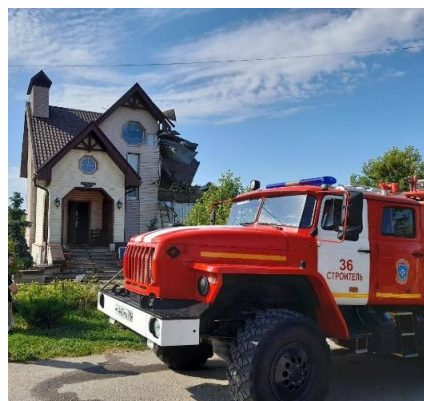
Figure 16. Example of the effects caused by attack elements neutralized by the air defense system (Governor of Belgorod, 2024).

Air defense systems are critical military elements designed to detect and intercept enemy aircraft or missiles. These systems play a vital role in protecting strategic facilities and defending civilian settlements. However, as shown in Figure 16, the debris from neutralized elements can fall onto structures, sometimes destroying parts of residential buildings. This is a rare occurrence even with drones and UAVs. The damage to a structure, despite the prevention of an air attack, indicates that some physical impacts are inevitable. Additionally, the intervention of emergency teams and the containment
